**Flood Control Project Maintenance  
Levee Inspections**

**Spring 2011 Levee Inspection Results**

**Madera County FCWCA**

**Levee Inspection Report By Mile - Spring 2011**

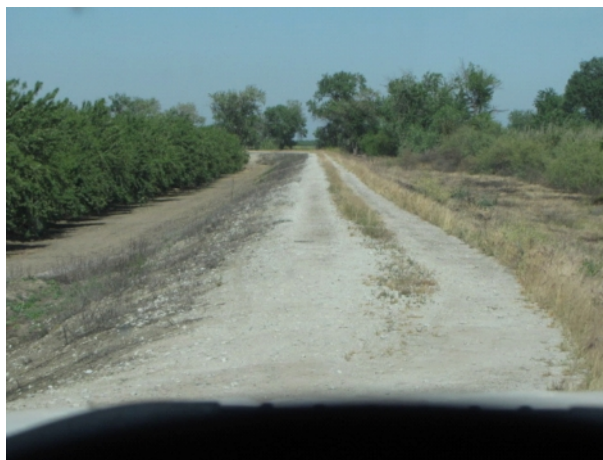
Levee Mile Report Line	3
Start Levee Mile	0.10
End Levee Mile	0.10
Location	Water Side
Category	Earthen Levee
Item	Vegetation

Stading at levee mile 0.00 looking upstream photo shows crown, waterside and landside of levee section. The mileage runs upstream. Photo taken 5-4-2011.

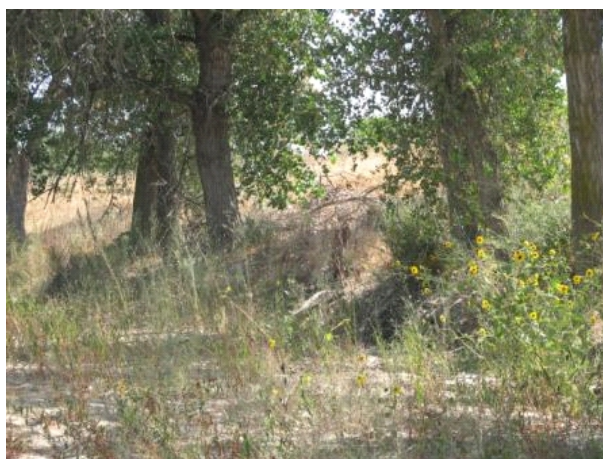
Levee Mile Report Line	8
Start Levee Mile	1.11
End Levee Mile	1.20
Location	Water Side
Category	Supplemental
Item	DWR Erosion Survey

Photo taken in 2007.

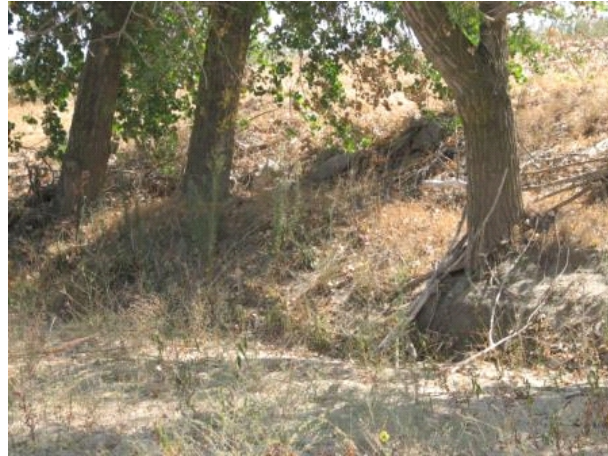
Levee Mile Report Line	8
Start Levee Mile	1.11
End Levee Mile	1.20
Location	Water Side
Category	Supplemental
Item	DWR Erosion Survey

Photo taken in 2007.

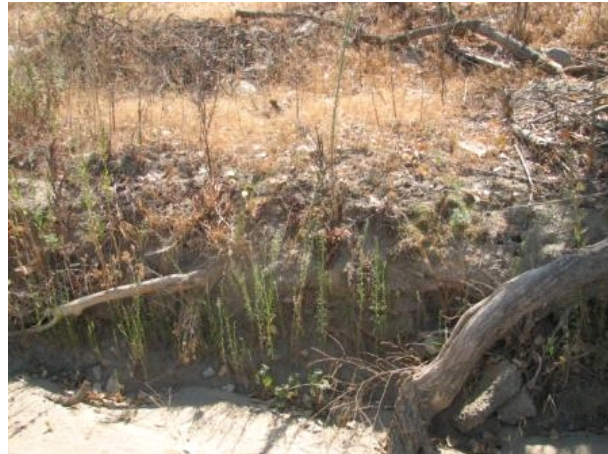
Levee Mile Report Line	8
Start Levee Mile	1.11
End Levee Mile	1.20
Location	Water Side
Category	Supplemental
Item	DWR Erosion Survey

Photo taken in 2007.

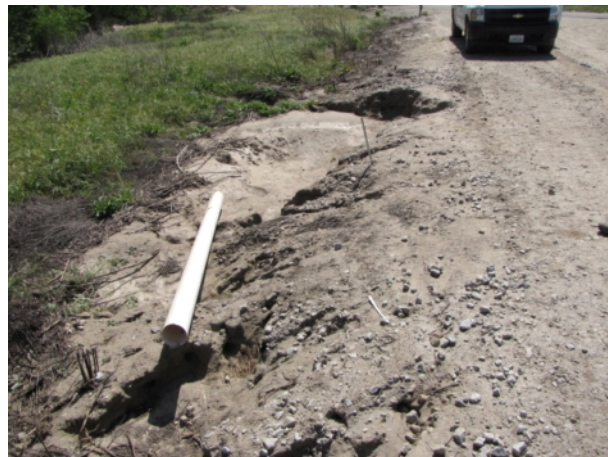
Levee Mile Report Line	10
Start Levee Mile	2.09
End Levee Mile	2.10
Location	Water Side
Category	Earthen Levee
Item	Slope Stability

This damage was caused by the land owner of the property landward of this location. The District will be sending out letters to the owner. Photo taken 5-4-2011.

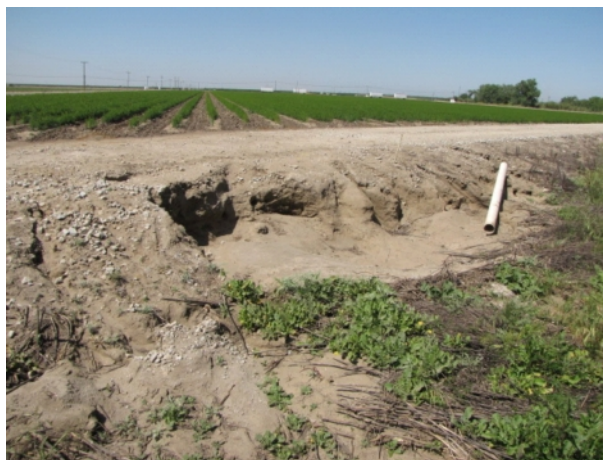
Levee Mile Report Line	10
Start Levee Mile	2.09
End Levee Mile	2.10
Location	Water Side
Category	Earthen Levee
Item	Slope Stability

This photo shown from waterside looking downstream. 5-4-2011

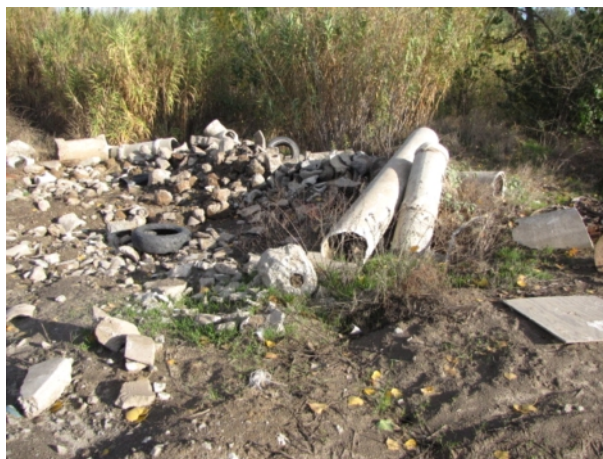
Levee Mile Report Line	11
Start Levee Mile	2.37
End Levee Mile	2.37
Location	Water Side
Category	Earthen Levee
Item	Encroachments

Pipe discarded along water side of Ash Slough and concrete rubble wastes on banks, during Spring inspection there were more materials, pipe, tires and concrete blocks. Most have been removed. All need to be removed from levee section. Photo taken 11-22-2010.

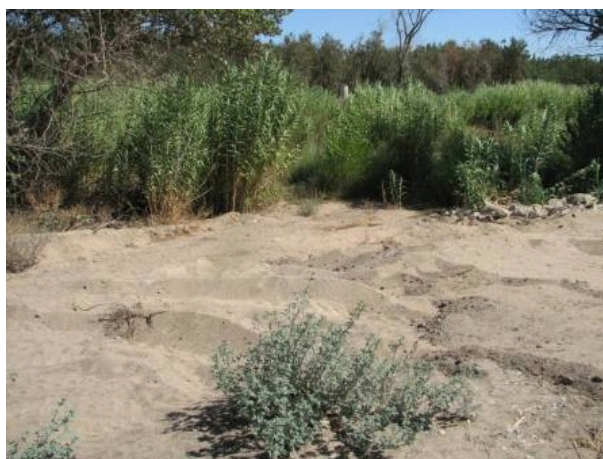
Levee Mile Report Line	12
Start Levee Mile	2.37
End Levee Mile	2.39
Location	Water Side
Category	Supplemental
Item	DWR Erosion Survey

12	2.37	2.39	Supplemental	DWR Erosion Survey	WS	M	Inspector Comments: 11/30/2010: Site was not inspected this year due to time constraints. There have been no reports from the district that this site was corrected. Continue monitor during flood events. 08/05/2010: Recommended for annual assessment and monitoring during flood events, per CLRO. [2010 SiteID: NA0011U01RM3.8]	37.068570 ° -120.398620 °	37.068570 ° -120.398620 °	2 Y

Photo taken in in 2008.

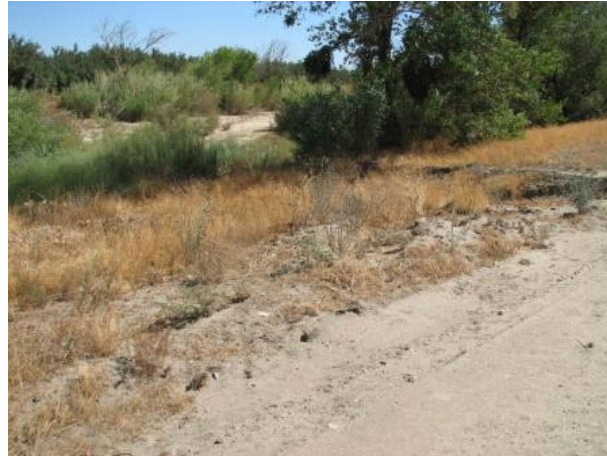
Levee Mile Report Line	12
Start Levee Mile	2.37
End Levee Mile	2.39
Location	Water Side
Category	Supplemental
Item	DWR Erosion Survey

Photo taken in 2008.

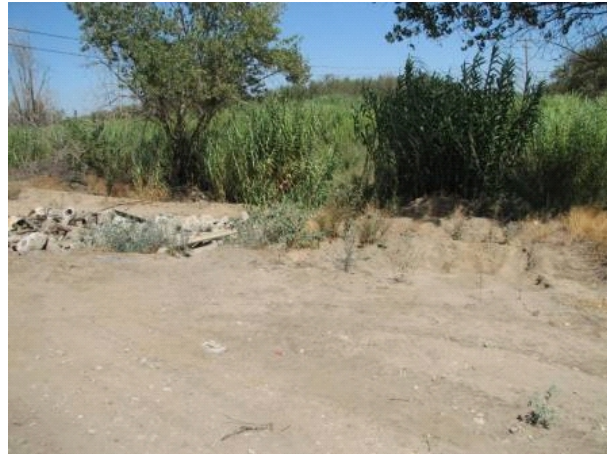
Levee Mile Report Line	12
Start Levee Mile	2.37
End Levee Mile	2.39
Location	Water Side
Category	Supplemental
Item	DWR Erosion Survey

Photo taken in 2008.

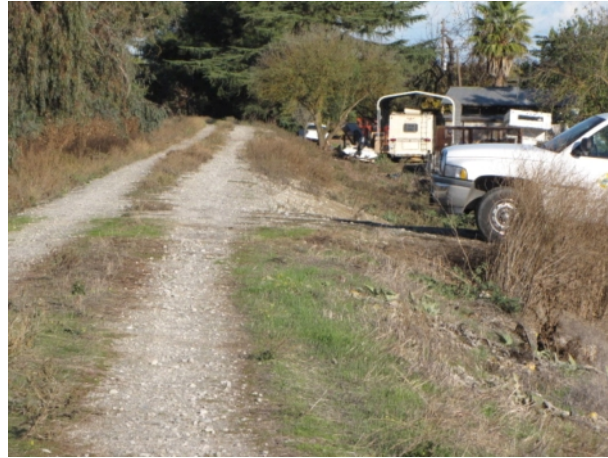
Levee Mile Report Line	1
Start Levee Mile	0.00
End Levee Mile	0.00
Location	Land Side
Category	Earthen Levee
Item	Vegetation

Looking downstream from levee mile 0.00 land side of Unit 2 Left bank. Photo taken 11-22-2010

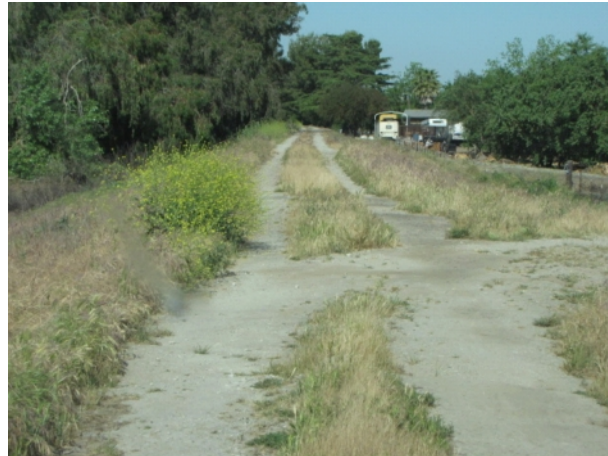
Levee Mile Report Line	1
Start Levee Mile	0.00
End Levee Mile	0.00
Location	Land Side
Category	Earthen Levee
Item	Vegetation

Standing at the downstream end of Unit 2 levee mile 0.00 looking upstream, photo shows growth on both slopes and crown roadway. The Maintaining Agency has this Unit scheduled for mowing. Photo taken 5-4-2011

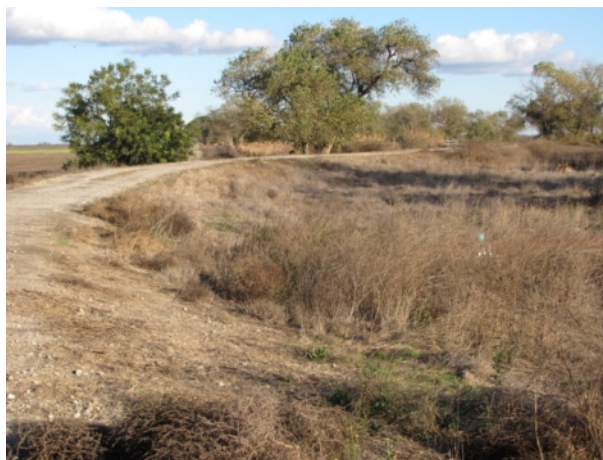
Levee Mile Report Line	1
Start Levee Mile	0.00
End Levee Mile	0.00
Location	Land Side
Category	Earthen Levee
Item	Vegetation

Looking down stream from levee mile 0.00 water side the brush appears to have been sprayed but not mowed. Photo taken 11-22-2010

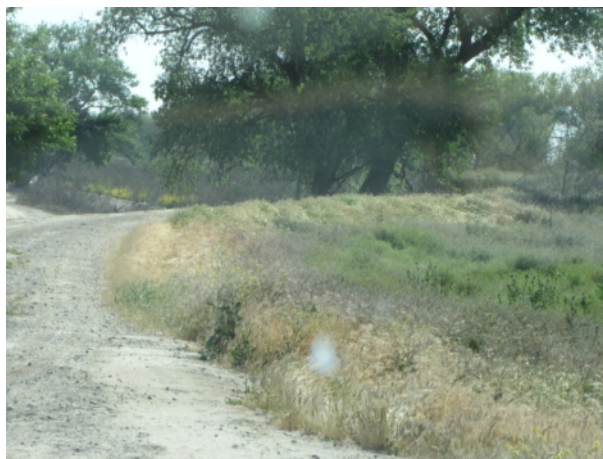
Levee Mile Report Line	1
Start Levee Mile	0.00
End Levee Mile	0.00
Location	Land Side
Category	Earthen Levee
Item	Vegetation

Standing at levee mile 0.00 looking upstream of the waterside slope. The mileage runs upstream. Photo taken 5-4-2011.

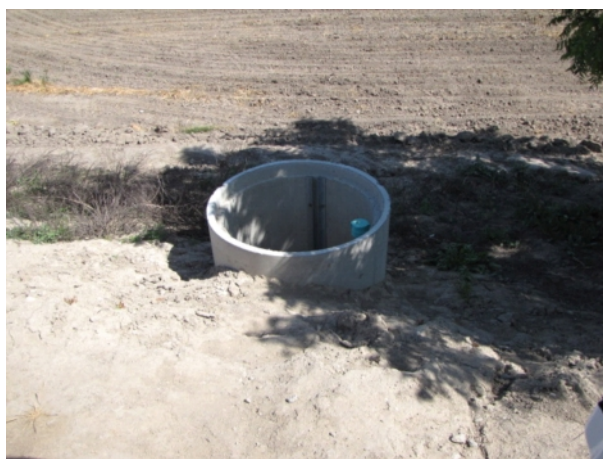
Levee Mile Report Line	2
Start Levee Mile	0.09
End Levee Mile	0.09
Location	Land Side
Category	Earthen Levee
Item	Encroachments

This stand pipe was installed within the landward slope and toe of the Right Bank Unit 3 levee mile 0.09. No permit from Central Valley Flood Flood Control. Photo taken 5-4-2011.

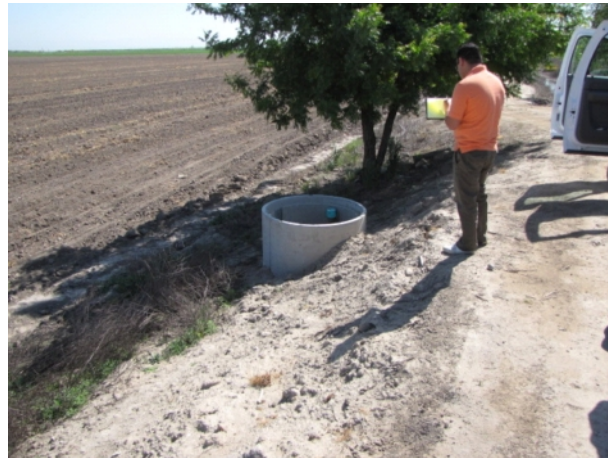
Levee Mile Report Line	2
Start Levee Mile	0.09
End Levee Mile	0.09
Location	Land Side
Category	Earthen Levee
Item	Encroachments

Standing upstream end of stand pipe within the landward slope and toe of levee mile 0.09 Unit 3. Mileage runs upstream.

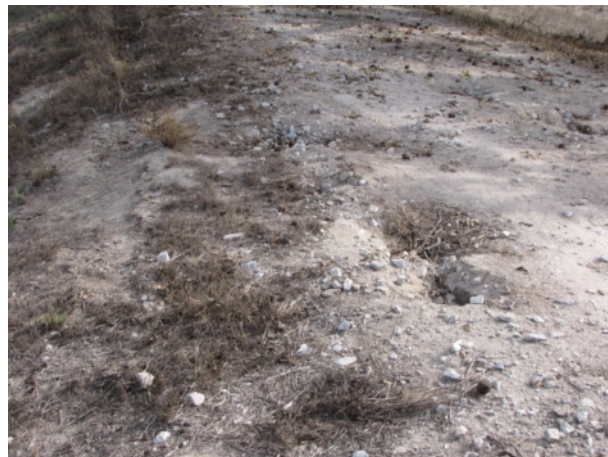
Levee Mile Report Line	12
Start Levee Mile	1.50
End Levee Mile	1.53
Location	Crown
Category	Earthen Levee
Item	Animal Control

There are several rodent holes in the shoulder and crown of the road way.

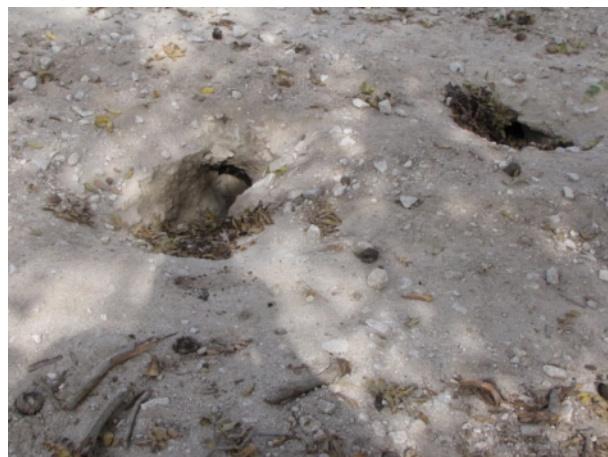
Levee Mile Report Line	12
Start Levee Mile	1.50
End Levee Mile	1.53
Location	Crown
Category	Earthen Levee
Item	Animal Control

This photo show holes in crown and shoulder.

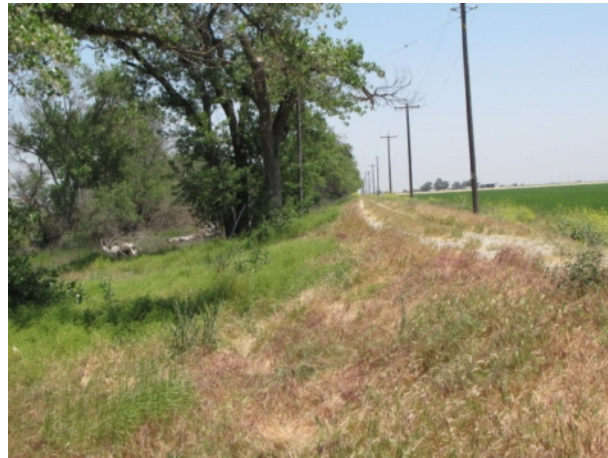
Standing on the waterward slope looking upstream from levee mile 0.00. These weed are scheduled for mowing. Today the mowers are working oer on Unit 5 and Unit 6 Fresno River. This photo was taken 5-4-2011.

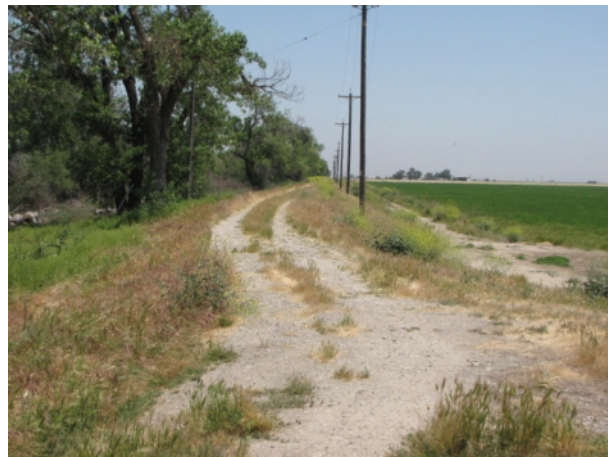
Levee Mile Report Line	2
Start Levee Mile	0.00
End Levee Mile	0.00
Location	Crown
Category	Earthen Levee
Item	Vegetation

This photo shows the crown roadway Unit 4 left bank of Berenda Slough. Mileage runs upstream. Both the land and waterward slopes can be viewed. Photo taken 5-4-2011

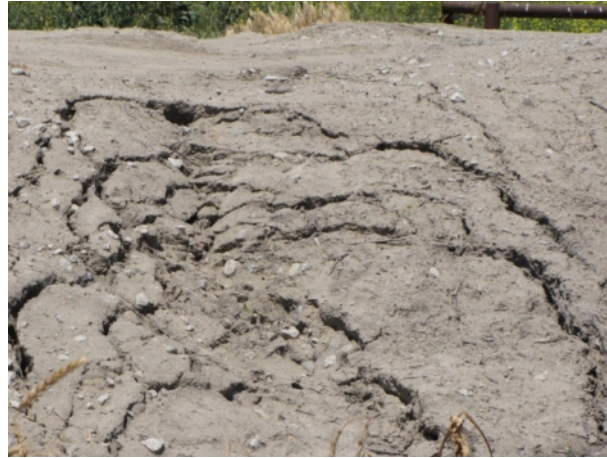
Levee Mile Report Line	6
Start Levee Mile	1.51
End Levee Mile	1.51
Location	Land Side
Category	Earthen Levee
Item	Slope Stability
<p>Standing on Ave. 17 looking at levee damage levee mile 1.51 (36.99561107 -120.3462358). The damage is just upstream of Road 11</p> <p>phillips_s_20110510_296.jpg</p>

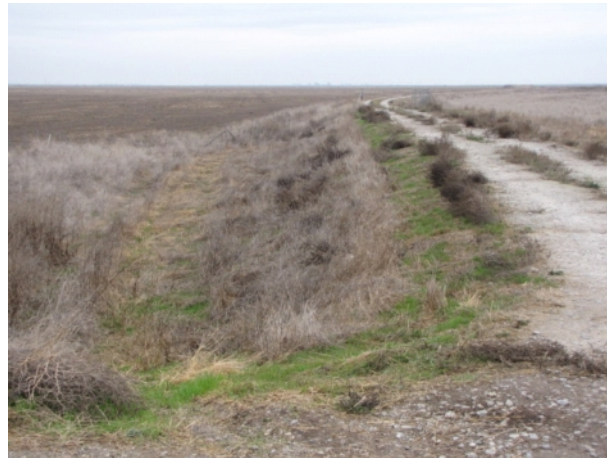
Looking downstream from levee mile 0.00 land side of Unit 5 Fresno River. Photo taken 11-24-2010

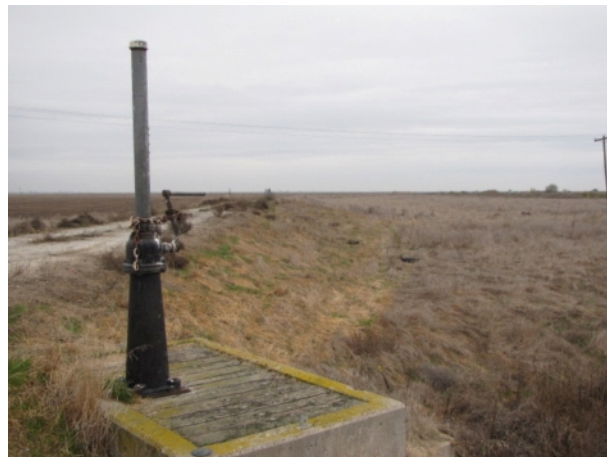
Levee Mile Report Line	1
Start Levee Mile	0.00
End Levee Mile	0.00
Location	Land Side
Category	Earthen Levee
Item	Vegetation

Looking down from levee mile 0.00 water side Unit 5 Fresno River. Photo taken 11-24-2010

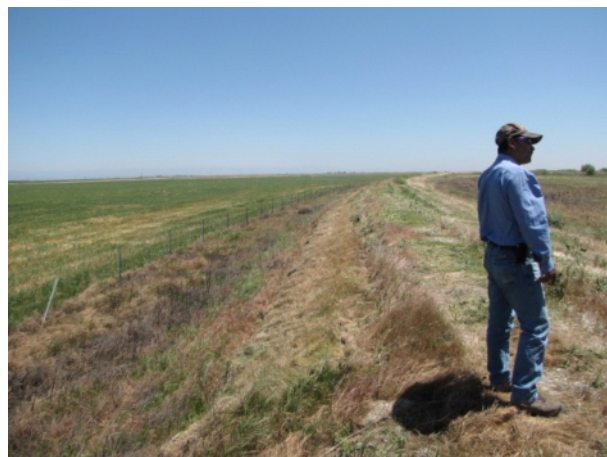
Levee Mile Report Line	2
Start Levee Mile	0.00
End Levee Mile	3.10
Location	Crown
Category	Earthen Levee
Item	Vegetation

Fresno River unit 5 looking downstream. 5-3-2011

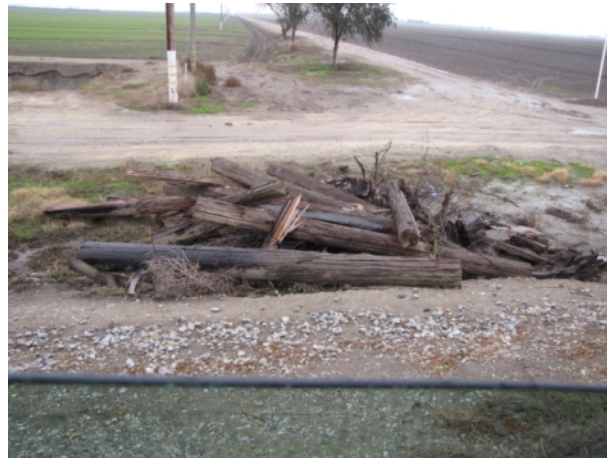
Levee mile 5.72 discarded power poles on landside toe need to be removed from levee section. Photo taken 11-23-2010

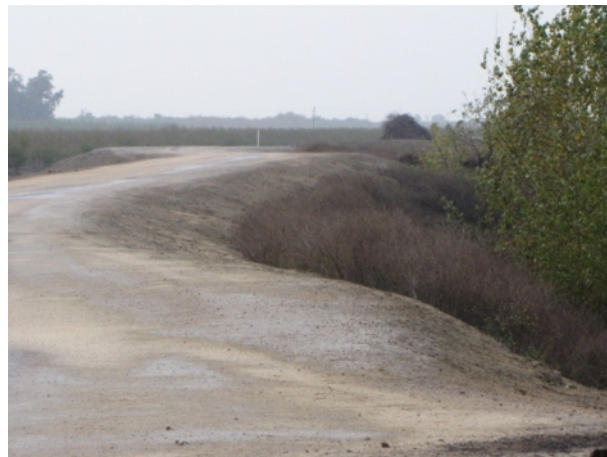
Levee Mile Report Line	8
Start Levee Mile	9.14
End Levee Mile	9.14
Location	Land Side
Category	Earthen Levee
Item	Vegetation

Standing at levee mile 9.14 water looking upstream of Unit 6 of Fresno River. Phot taken 11-23-2010

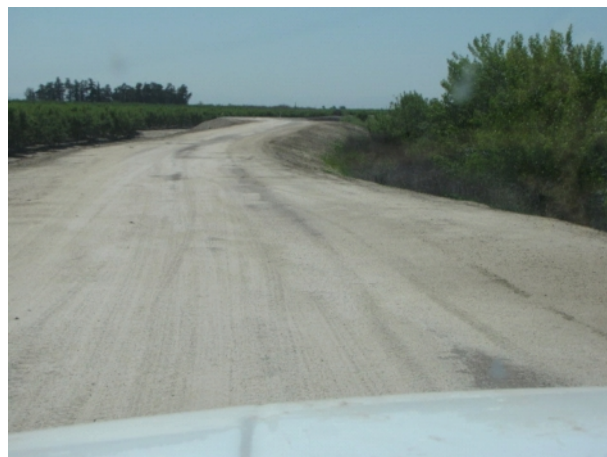
Levee Mile Report Line	8
Start Levee Mile	9.14
End Levee Mile	9.14
Location	Land Side
Category	Earthen Levee
Item	Vegetation

Standing at levee mile 9.14 looking downstream of waterside Unit 6, starting my inspection at the downstream end of Unit 6. Mileage run downstream. Photo taken 5-3-2011.

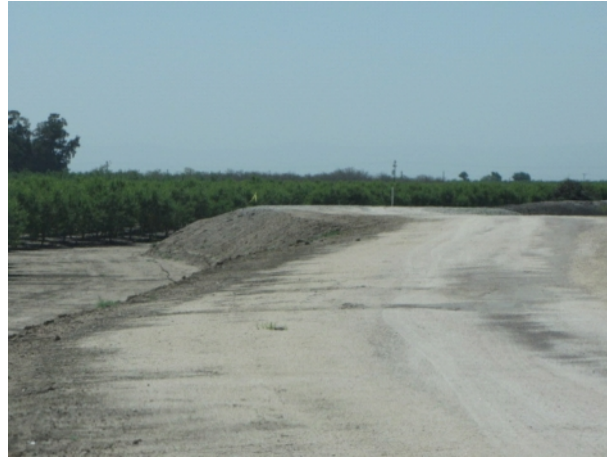
Standing at levee mile 9.14 looking downstream landside of unit 6. The landowner keeps this section of levee very clean of vegetation. Photo taken 5-3-2011.
